Investigative Report on Chemistry 301A Cylinder Explosion

Brent S. Mattox, CIH

Texas A&M University

January 29, 2006

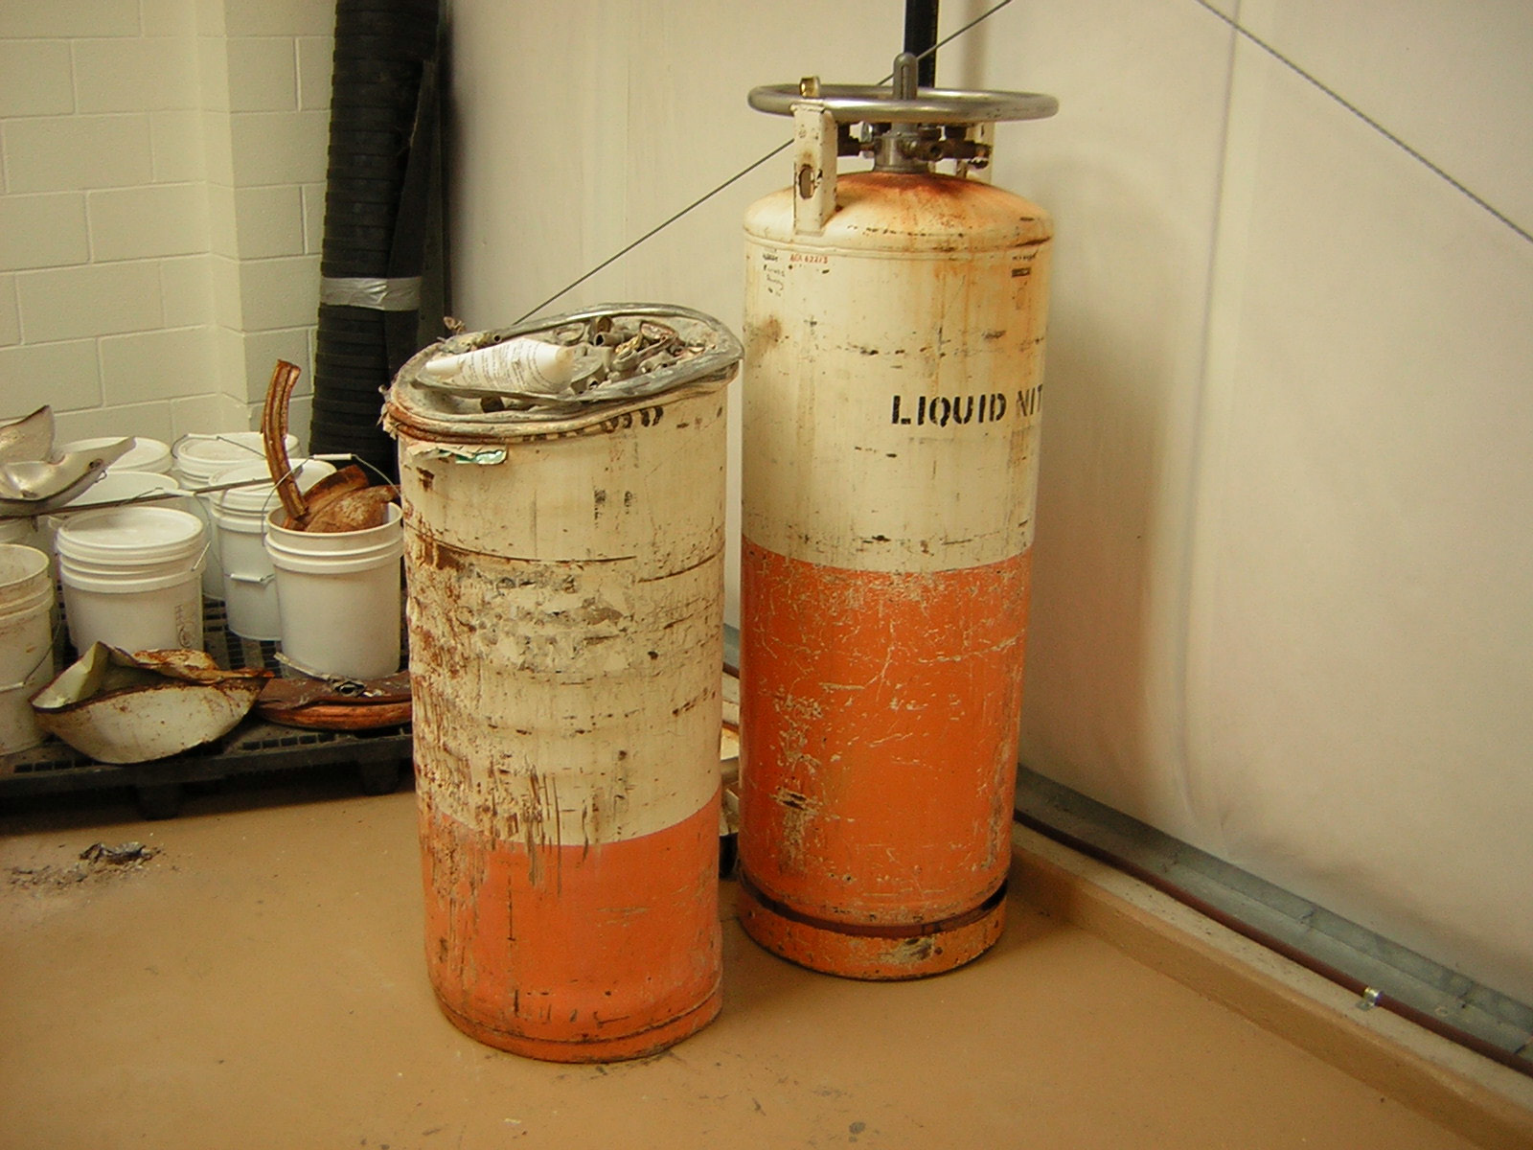
We first saw the remains of the cylinder that had been collected and stored in a maintenance building. Since the explosion was contained in the Chemistry building virtually all of the pieces of the cylinder were recovered. The cause of the explosion was immediately evident from the parts. The cylinders two safety devices, the 230 psi relief valve and 400 psi rupture disk, had been removed and replaced with pipe plugs. The resulting overpressure failure of the cylinder was a textbook example. With no outlet for the gas the cylinder slowly built pressure until the hoop stress exceeded the yield strength of the inner vessel. The inner vessel expanded until it contacted the outer vessel, as clearly seen by the impressions the gas use tube made on both the inner and outer vessel as it was crushed between them. The outer vessel reinforced the inner against much further circumferential expansion and the pressure continued to build until the longitudinal stress in the cylinder exceeded its yield strength, resulting in the separation of the bottom head from the vessel. As this separation occurs between 1000-1200 psi the 250,000 pounds of force drove the inner bottom head through the outer and propelled the cylinder into the ceiling of the lab causing extensive damage to the building. The remains of the inner vessel showed no signs of corrosion or abuse, so overpressure appears to be the sole cause of the failure.

The only remaining issue is why were both relief devices replaced with pipe plugs? When this has happened in the past the typical scenario is something like this. The rupture disk on the cylinder blows from age. The local maintenance person doesn't have a rupture disk so it is replaced with a pipe plug and the cylinder is returned to service. Everything is fine for years until something causes the relief valve to leak and it too is replaced with a plug, leading to the inevitable failure soon after. When this happens the pipe plugs typically look different, since they were replaced at different times. The only thing a bit unusual about this accident is that the plugs looked identical. Both the same size, shape and apparent age, both installed with Teflon tape, leading you to believe that both were replaced at the same time by someone that understood plumbing. This being said realize that they weren't in pristine condition, after traveling through 6 inches of concrete. While there were many pictures taken at the site the three attached sum it up.

We saw 3 other liquid cylinders on the property, a Ryan, a Linde, and another MVE (Dura 5500). All were well maintained, none had ever been tipped over, probably due to the use of Harper carts for handling. All the correct rupture disks and relief valves were in place. I recommended that they institute a training and PM program for their remaining cylinders based on CGA guidelines and at minimum retest or replace the primary relief valves every five years.

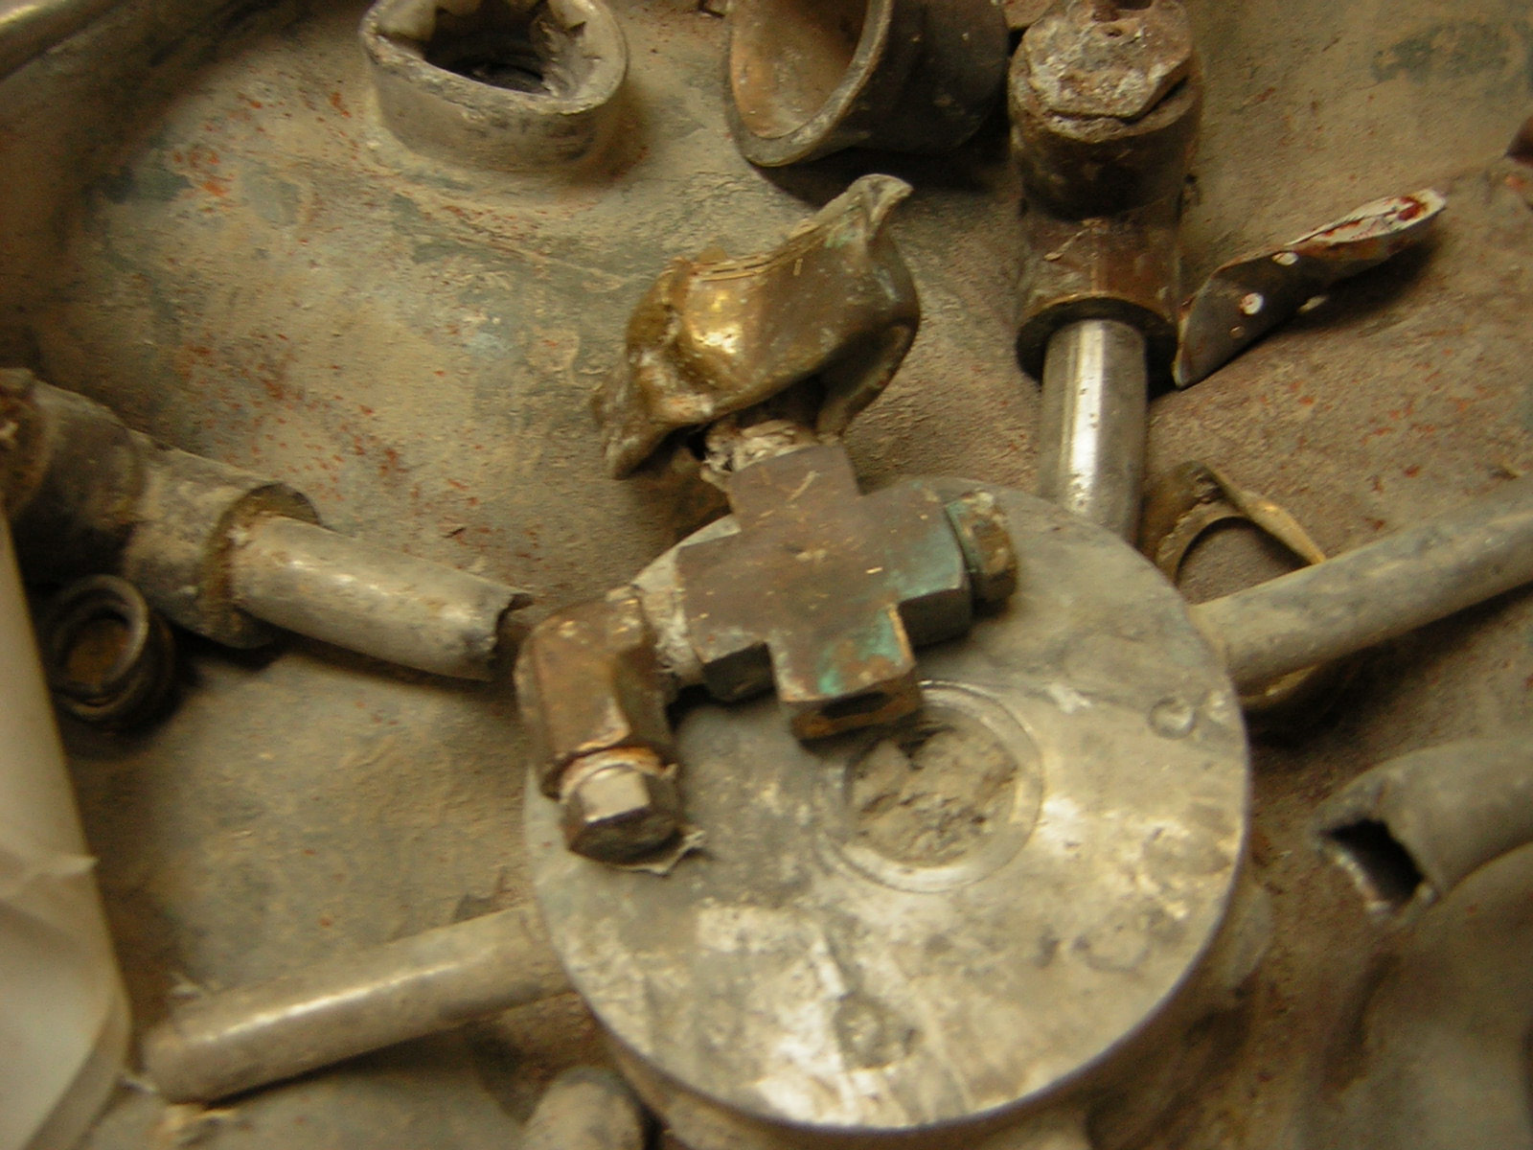
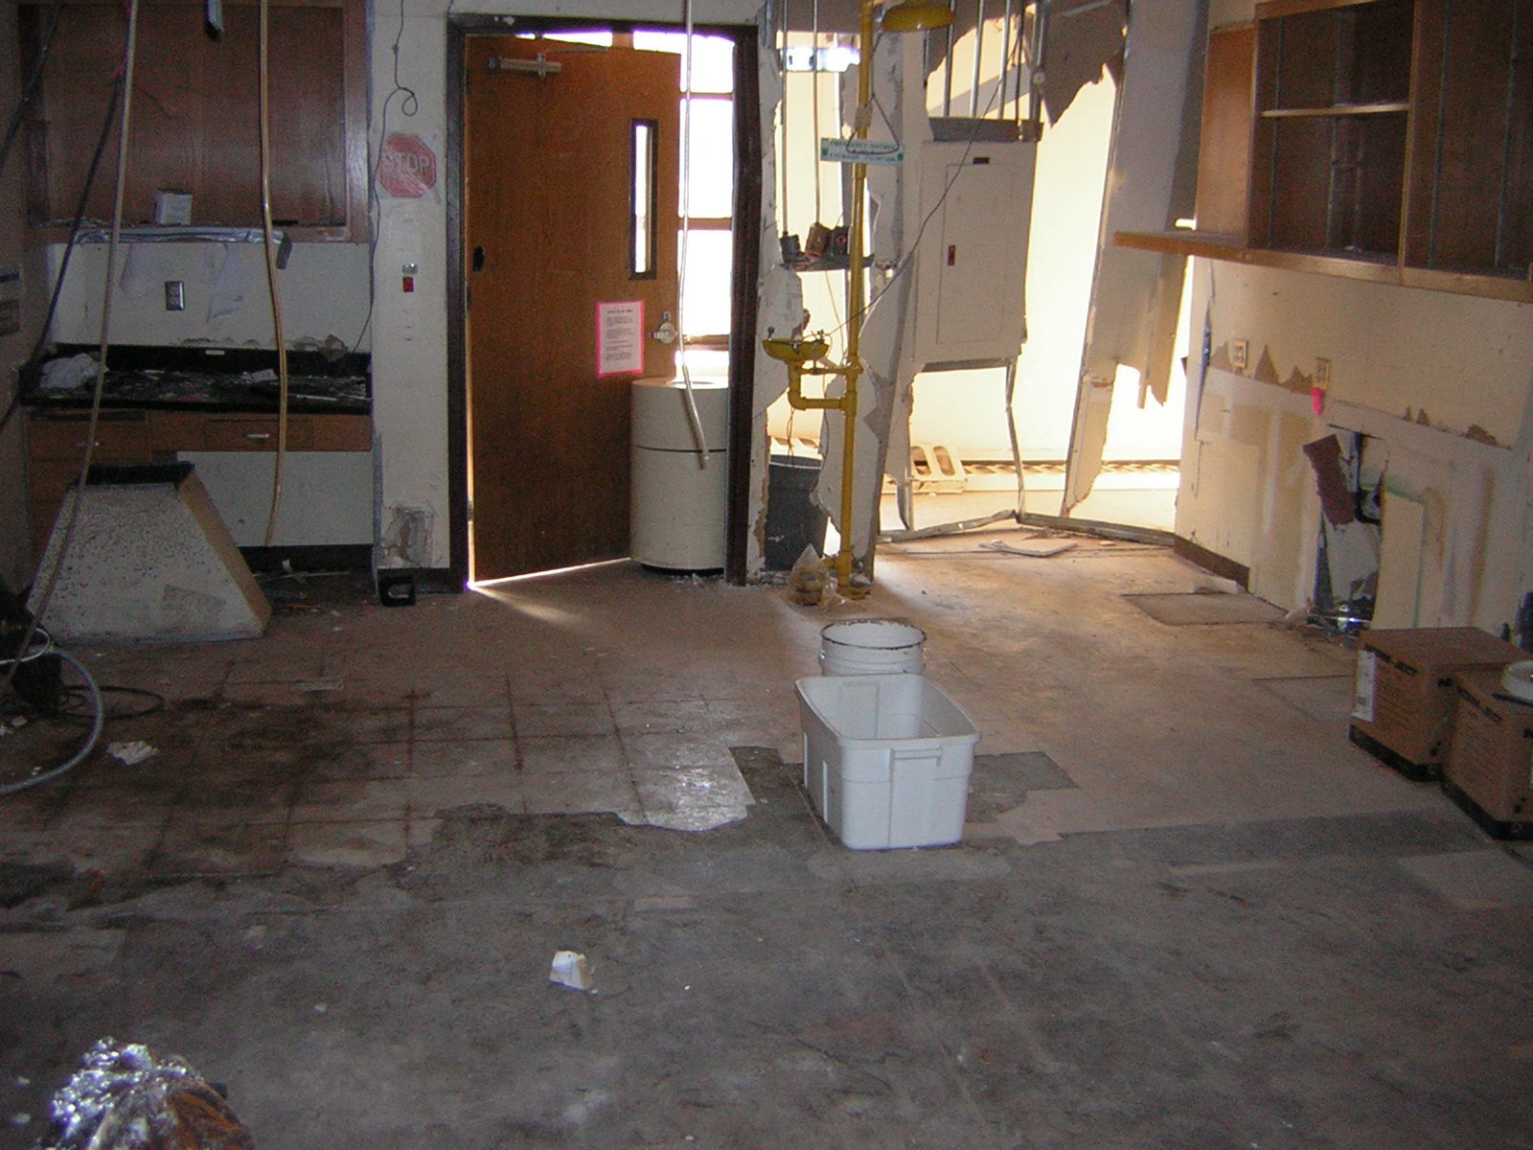
that you could see on the external tank where the vaporizer piping that loops around the internal tank had been pressured by the swelling of the internal tank, forming visible rings on the external tank. All of these, according to Mr. Gustafson, were a direct indication that the pressure relief and the rupture disk had probably failed at sometime in the past and the openings sealed. Without these two safeguards in place, it was only a matter of time until an explosion occurred. When queried as to why it had not exploded earlier, Mr. Gustafson pointed out it depended on how quickly the nitrogen was used after filling.

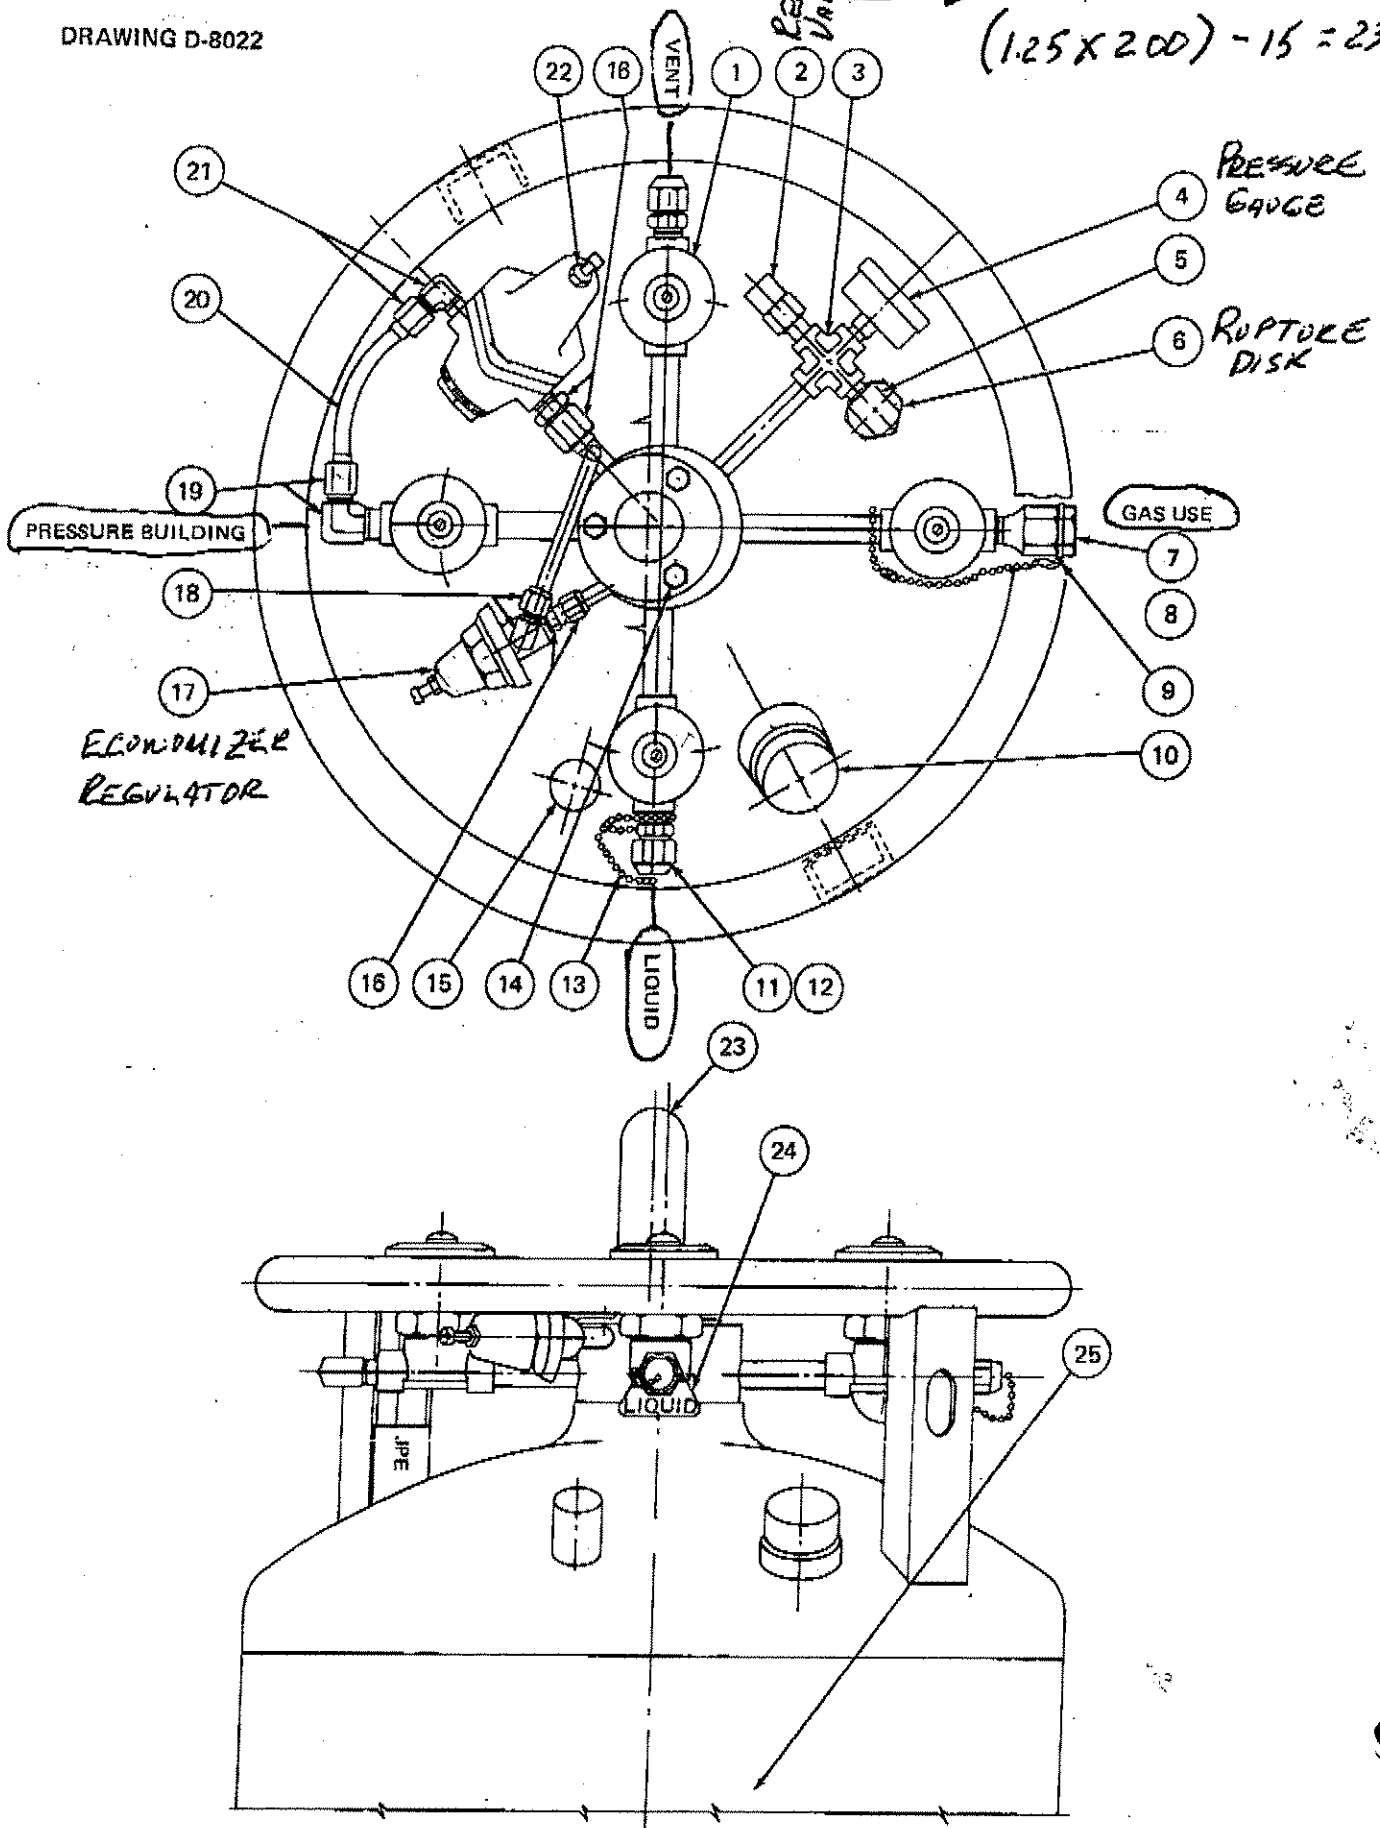
DRAWING D-8022

RELIEF VALVE → MAX. PRESSURE
(1.25 X 200) - 15 = 235 ψ
